# Evaluation Report 300

## Krone KR180 Baler

## KRONE KR180 BALER

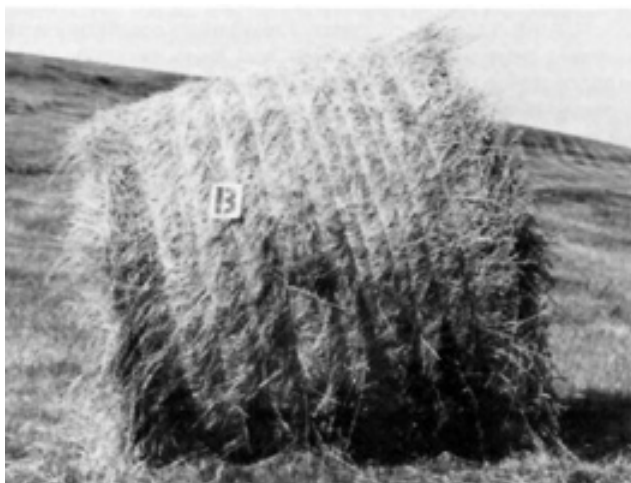
greenfeed, bale quality was reduced to fair as it was difficult to consistently produce bales of uniform diameter and adequate durability (FIGURE 3). Similar to most round balers, it was also difficult to consistently produce uniform, durable bales in dry, short, chopped up straw, similar to that combined with rotary combines. In short straw conditions, bale quality was greatly improved if the straw was baled when slightly tough.

FIGURE 3. Inadequate Bale Density in Light Dry Material.

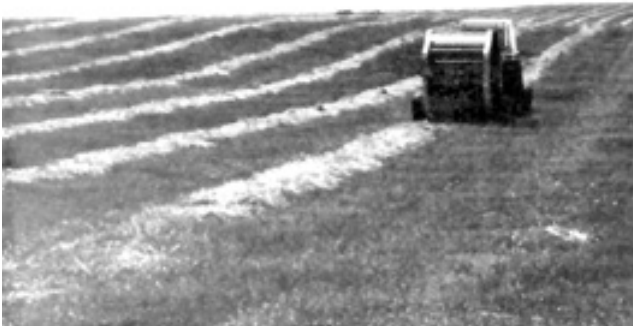
In light, dry crop conditions, the bales would often have to be wrapped and discharged prematurely. When the bale was nearing completion the rear gate would open slightly, allowing the windrow to drop back on the ground behind the baler (FIGURE 8) before the hydraulic pressure gauge indicated the bale was ready for wrapping. The bale would then have to be wrapped and discharged as the rolling bale would not take up any more hay. In these conditions, bale quality was only fair due to the inability to produce bales of adequate density. Also, since visibility to the rear was limited, the operator had difficulty in determining when hay would begin dropping out the back. It was inconvenient to rebale the portions of windrow left behind. The operator's manual indicated that the gate was to open slightly and drop the windrow back on the ground when the bale chamber was overfilled. However, the gate began to open before the hydraulic system relief pressure was reached. Increasing the relief pressure only improved the problem slightly. It is recommended that modifications be considered to prevent the

**FIGURE 8.** Windrow Dropping Out Behind the Baler in Light, Dry Crop Conditions.

1. Modifications to prevent the rear gate from opening prematurely, allowing hay to drop out when baling in light, dry windrow conditions.
2. Modifications to prevent the base of the hitchjack from unscrewing due to vibrations.
3. Modifications to improve pickup floatation to prevent pickup damage on rough or stony ground.
4. Supplying a slow moving vehical sign as standard equipment.
5. Modifications to eliminate premature failure of the frame bolts.

rear gate from opening prematurely, allowing hay to drop out when baling in light, dry windrow conditions.

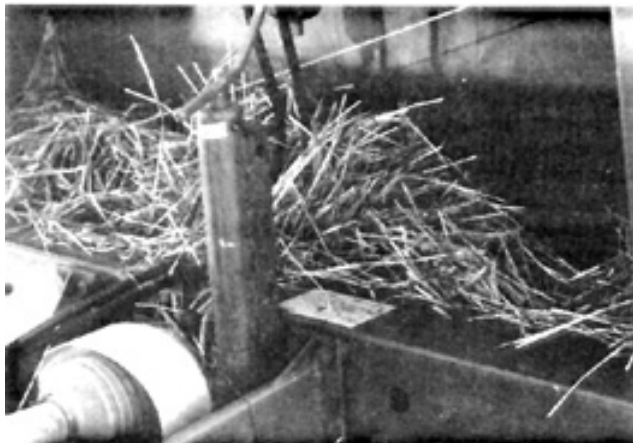
In dry straw, backfeeding presented several problems. Straw piled up on the windguard, jamming between the back panel of the twine box and the front bale chamber housing (FIGURE 9). Removing the pickup windguard allowed baling in these conditions. Also, at the beginning of the twine process, when the wrapping process begins on the right side, straw would continue to backfeed on the left side, piling up on the ground in front of the pickup. The result was a poor, lopsided bale. Baling straw when it was slightly tough, greatly reduced backfeeding and improved bale quality.

**FIGURE 9.** Dry Straw Piled On the Pickup Windguard Due to Backfeeding.

**Feeding:** Feeding was positive in most crops with only infrequent plugging. In most straw conditions it was necessary to remove the pickup windguard to prevent straw from piling up on the windguard due to backfeeding. In very short straw, this resulted in uneven feeding and excessive pickup losses. In fluffy straw and greenfeed windrows, feeding was improved with the windguard removed. Reduced ground speed was required when starting a bale in very heavy windrows to prevent plugging.

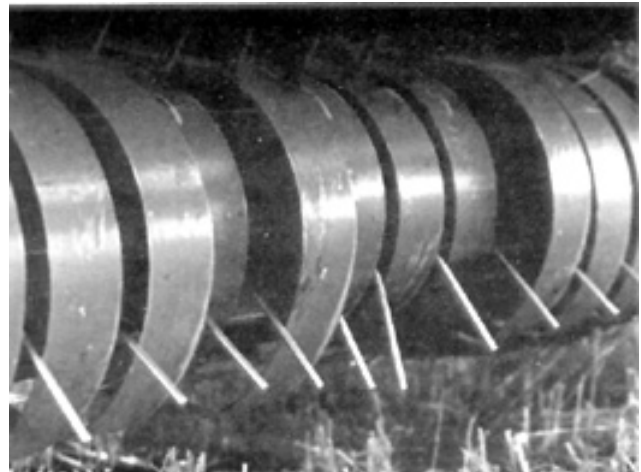
- A 6 mm flat washer was added to the rear gate relief valve to increase relief pressure at	86	656
<b>PICKUP</b>		
- The pickup was damaged, requiring repair of several pickup hoops, tooth bars and pickup teeth at	26	220
<b>FRAME</b>

**Pickup:** Poor pickup floatation allowed several pickup hoops, tooth bars and pickup teeth to be bent on rough ground (FIGURE 10). Care had to be taken to miss larger stones to prevent serious damage to the pickup. The pickup was not equipped with a floatation mechanism. It has already been recommended that the manufacturer consider modifications to improve pickup floatation.

FIGURE 10. Damaged Pickup.

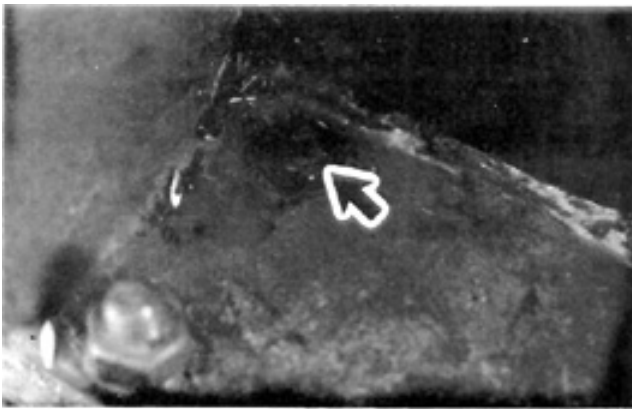
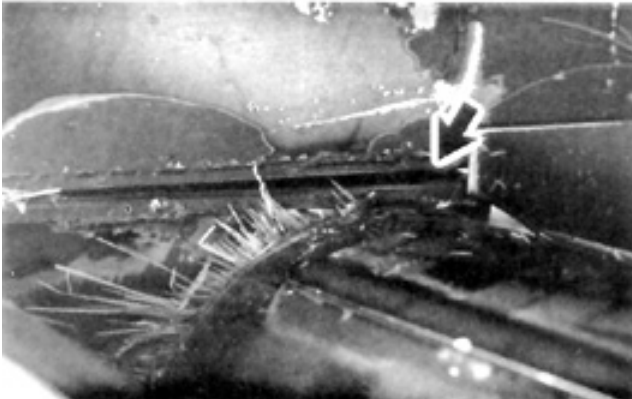
- Two bolts securing the front housing and the support brackets broke and a third was cracked, requiring replacement at	115	875

**Frame:** A frame bolt securing the front housing and the roller support brackets broke on each side and a third bolt was cracked. The failures were due to high tension loads and fatigue. FIGURE 11 illustrates the broken bolt and spreading between the front housing and the roller support bracket on one side. The bolt heads were welded to the frame making it difficult to replace the bolts. It is recommended the manufacturer consider modifications to eliminate premature failure of the frame bolts.

**FIGURE 11.** Frame Failure: (Upper) Broken Bolt, (Lower) Spreading Between the Front Housing and the Roller Support Bracket.

1. The new KR-181 Balers for the 1983 season has been fitted with a latch on the rear opening gate. This prevents the rear gate from opening prematurely. Even a small pressure loss from hydraulic fluid does not affect the situation.
2. A new hitchjack has been fitted.
3. The 1984 production machine will have two boots underneath the pickup and the pickup will have spring-assisted floatation.
4. We have not yet supplied a "Slow Moving Vehicle" sign as standard equipment, but this recommendation will be noted.
5. Better production control has been implemented to eliminate premature failure of the frame bolts.
